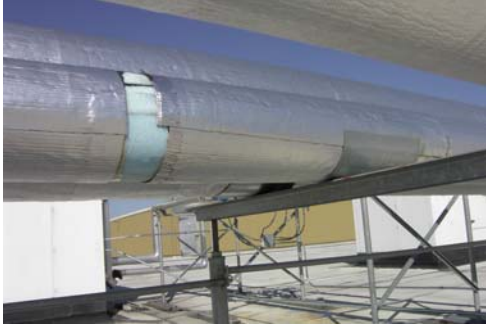
Before Photo "A" Oct. 9th 2003

The thermal expansion and contraction of the piping has caused the insulation vapor barrier to be pulled apart at the seams. The saddle supporting the insulation does not move to accommodate the thermal cycle of the piping.

The vapor barrier is repaired and Insul-Dry Sliding Saddles are installed several months prior to the Nov. 3rd 2004 photos. The low friction liner on the lower saddle allows the upper saddle and the pipe to move without putting excessive force on the vapor barrier seams.
